# Release Notes for Cisco TelePresence System Software Release IX 8

These release notes describe new features and open and closed hardware and software caveats for the Cisco TelePresence System software release IX 8. The Cisco TelePresence System IX5000 and IX5200 use this software.

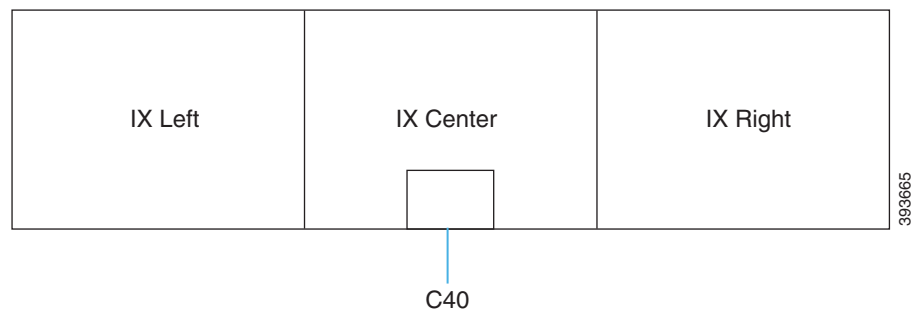
In Figure 1, the IX feed is displayed on the three main screens while the C40 codec feed is in the CMS-generated filmstrip as part of the center screen video feed.

**Figure 1 CMS Generated Filmstrip in Center Screen Video Feed**

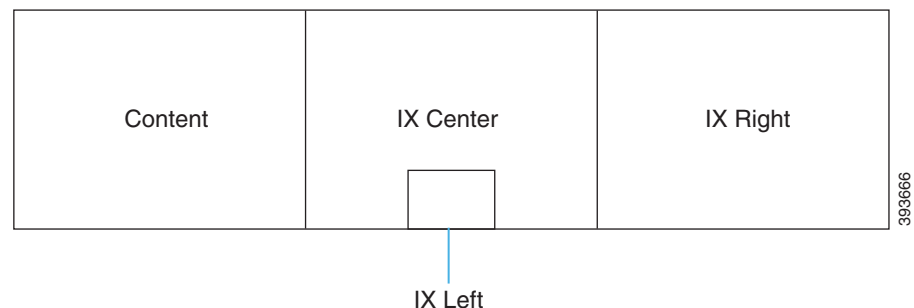
When the IX displays content in the left display, the left screen feed sent from CMS is placed into a local Picture in Picture (PiP) on the center display generated by the IX 5000 as shown in Figure 2. This PiP overlays any filmstrip coming from the CMS since it is part of the video feed.

**Figure 2 Left Screen from CMS Placed into Local PiP**

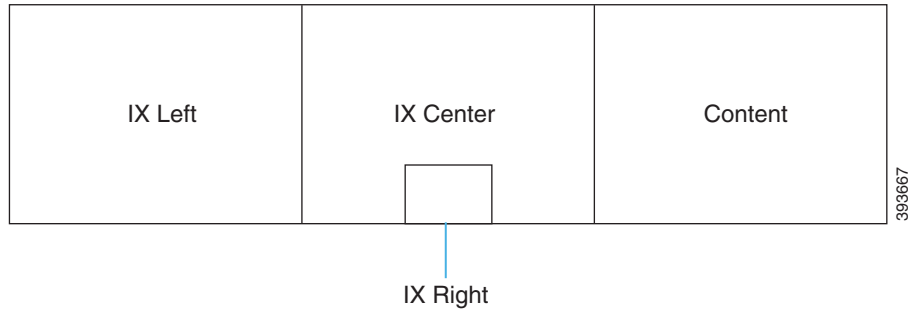
As shown in Figure 3, when the IX content moves to the right display, the right video feed from CMS is now overlaid on top of the PiP in the center screen.

**Figure 3 Right Video Feed Overlaid on PiP in Center Screen**

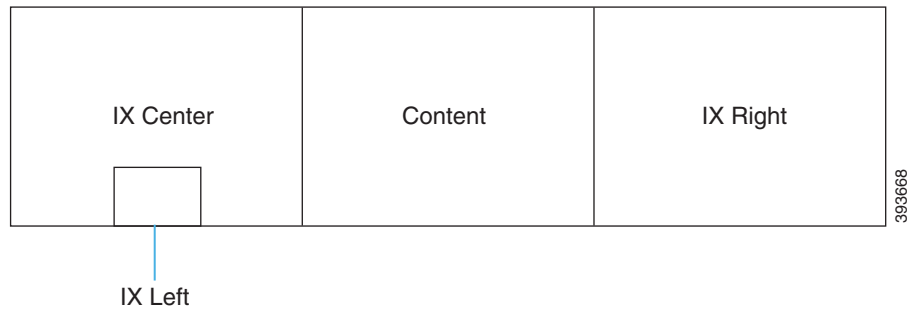
If the IX content is moved to the center display as shown in Figure 4, the center feed from CMS (with the included conference filmstrip) is now moved to the left display. The left video feed from CMS is now overlaid in the local PiP, blocking the filmstrip feed from the C40 codec. This switch takes place to prevent the center IX center stream from going to the small PiP and overlaying the conference filmstrip.

**Figure 4 Left Video Feed from CMS Overlaid in the Local PiP**

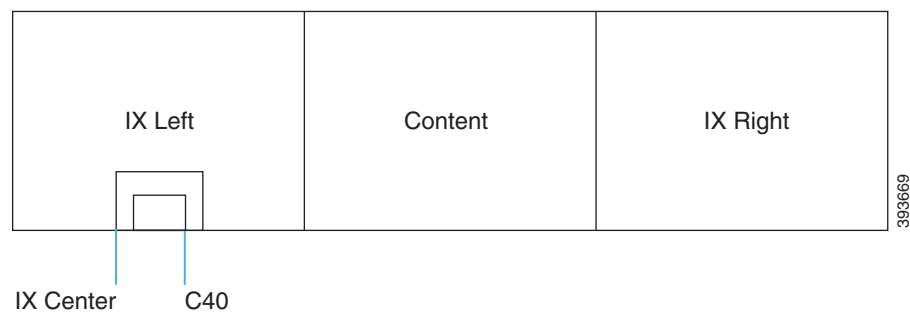
When in the previous state, the current PiP feed (in this case the left screen from CMS) becomes the active speaker. This causes the IX to move it to one of the full screen images, swapping it with the current video feed. That causes the left and center feeds to swap, putting the center screen feed from CMS in the small PiP window, as shown in Figure 5. Since the center feed from CMS also contains the filmstrip, a small filmstrip is displayed within the PiP window (that had been hidden previously because it was under the IX PiP overlay).

**Figure 5 Center Screen Feed from CMS Placed in PiP Window**
